Pennsylvania
Coastal Zone
Management Program

SHORELINE EROSION
AND FLOODING

ERIE COUNTY

June 1975

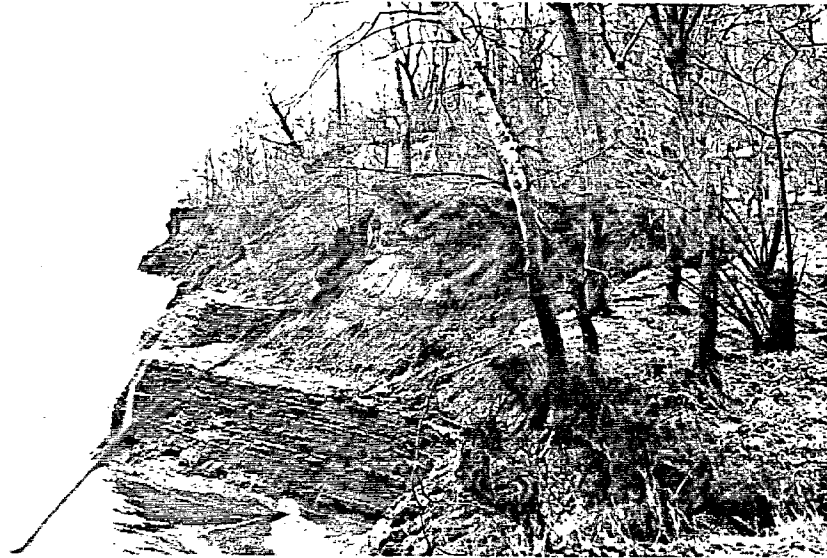
Above: Cuspate features in bedrock, Harborcreek Township

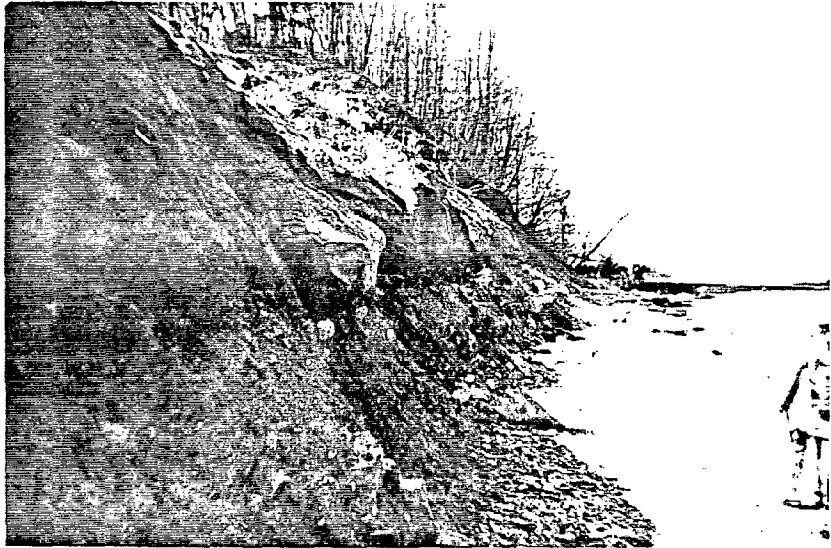
Above: Glacial tills overlain by clay and sand deposits

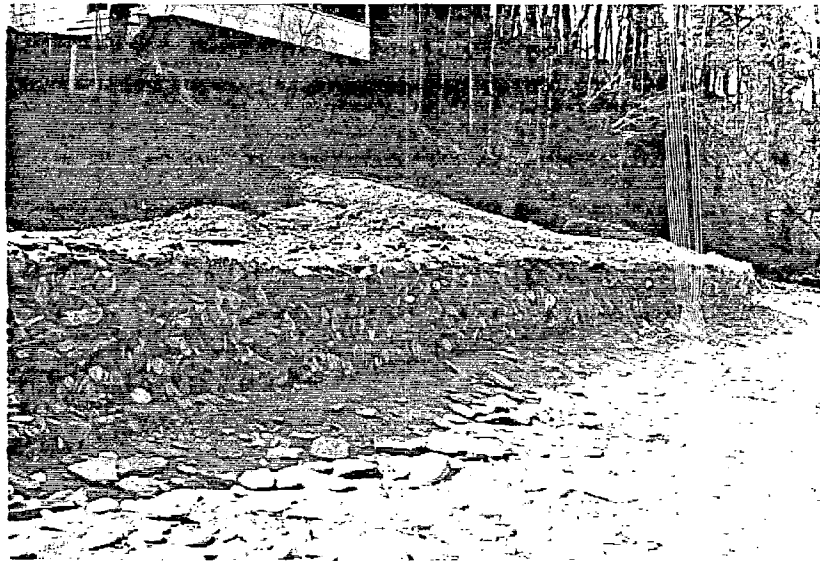
Above: Seawall constructed of rock-filled fence netting

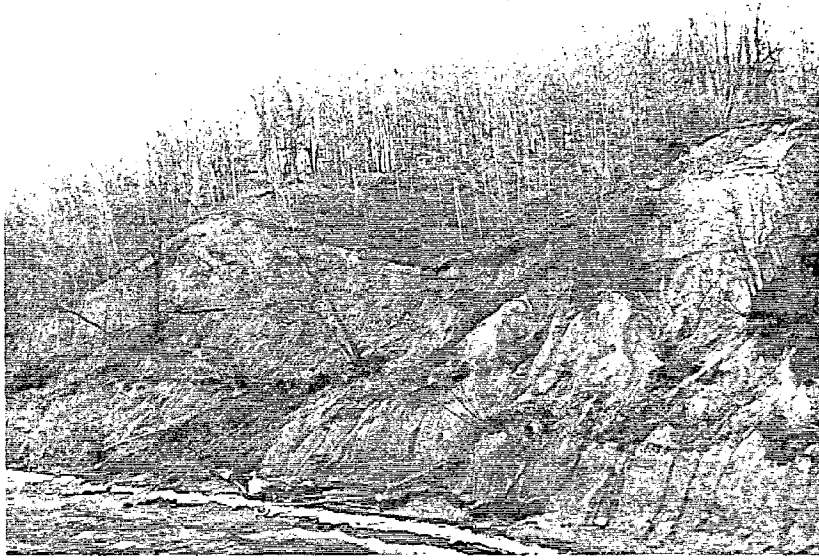
Above and below: Between Raccoon Creek and Ellis Road,
Springfield Township

SHORE ZONE
DESCRIPTION: Near vertical bluff; mass slumping evident. Grass
and trees on bluff crest and slope are disrupted.
Ground water is evident as a contributory factor
in recession.

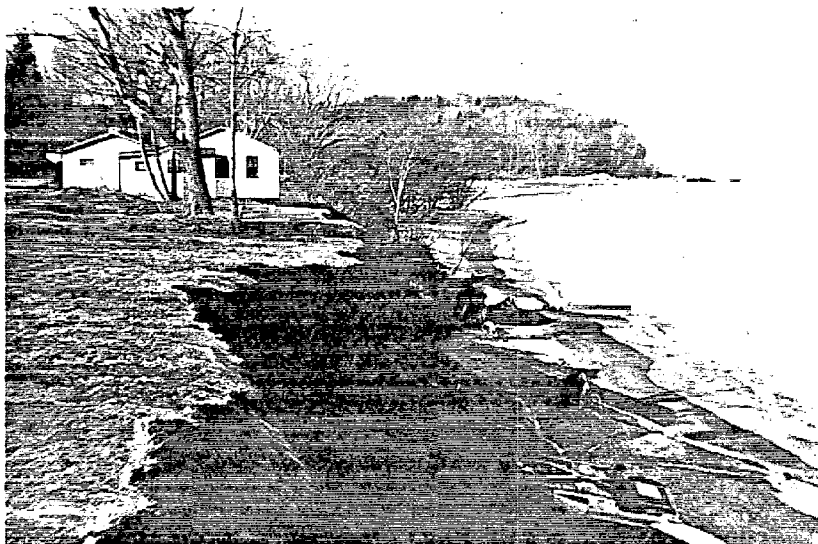
Above: Cottage overhanging bluff crest; view looking west toward mouth of Elk Creek, Girard Township; note abandoned cars at base of bluff

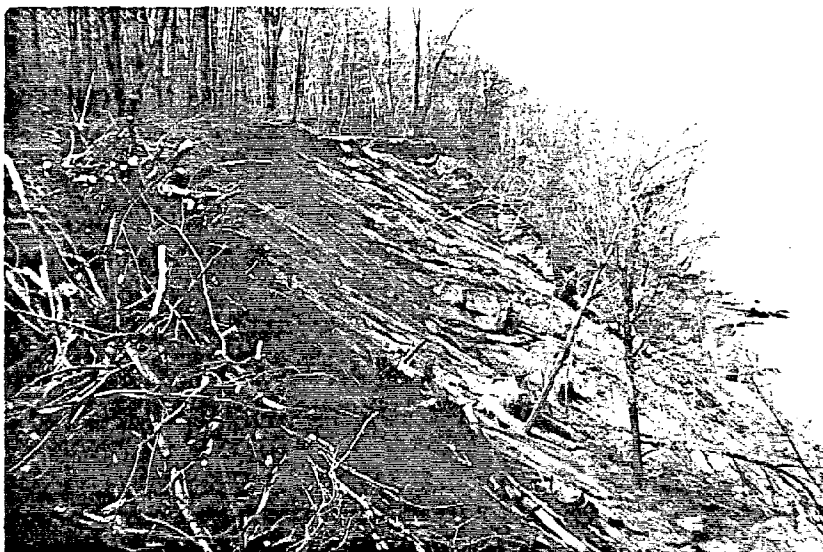
SHORE ZONE DESCRIPTION: The high bluffs with 60° slope are generally stable from Elk Creek to Lake Erie Community Park. In the park there are two massive slump blocks on 80° slopes which have been displaced downward to 10 ft. in the past two years. There are also several areas that have suffered rapid erosion and recession. This area is relatively unprotected with only a narrow beach strand during low water and occasional trees acting as temporary groins. The groin used by the cement works to collect sand and gravel has built up 25-50 ft. of beach and serves to protect and stabilize the eastern edge of the park. In the Lakelands area there is another large slump block similar to the ones in the park. There is periodic erosion interspersed with stable bluffs.

Above: Lake Erie Community Park, Girard Township showing
area of mass wasting

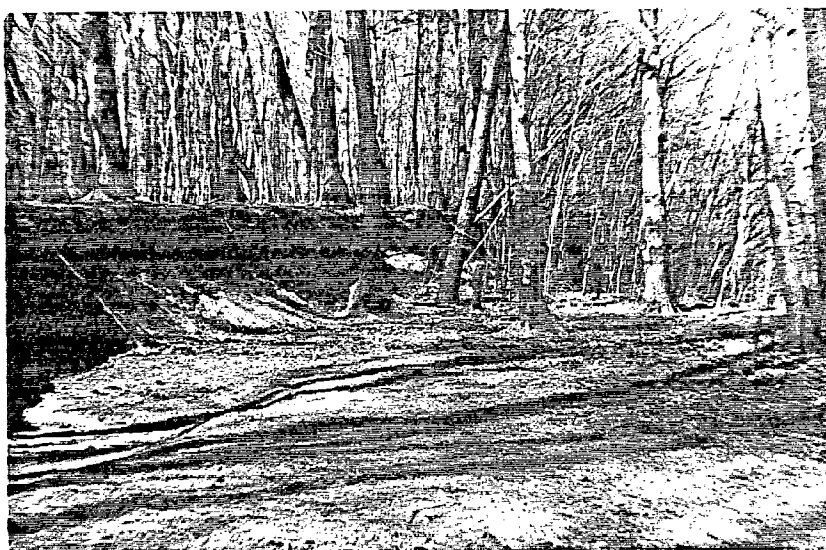
Above: Lake Erie Community Park, Girard Township; showing
vertical displacement of massive slump block

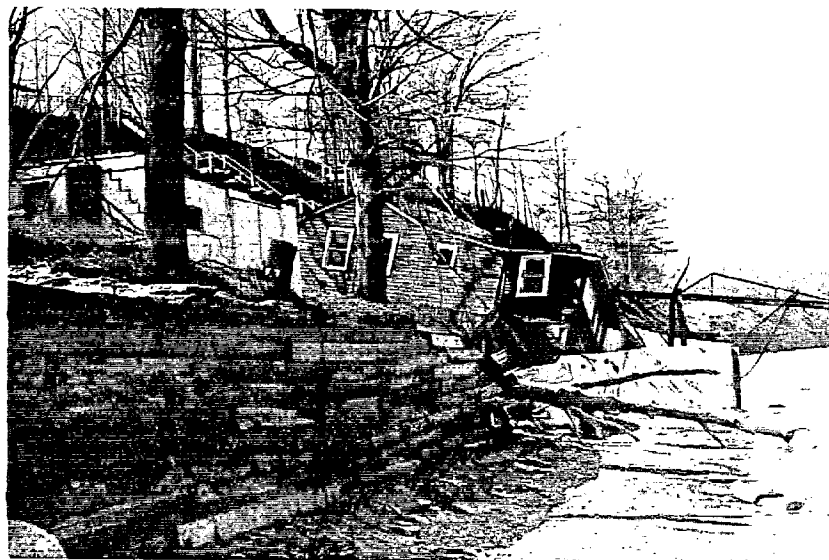
Above and below: Francroft Subdivision, North East Township;
showing destruction of boat houses and beach cottages

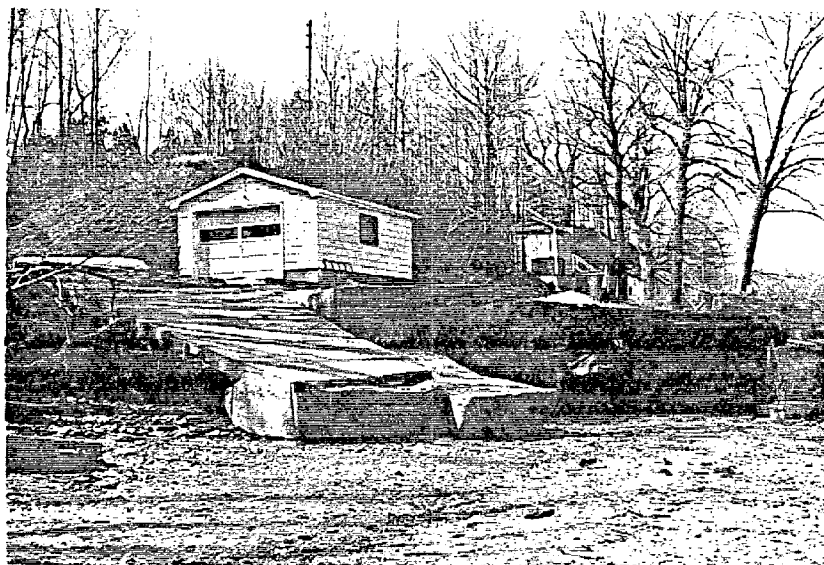
Above: Francroft Subdivision, North East Township; showing
disrupted boat ramp

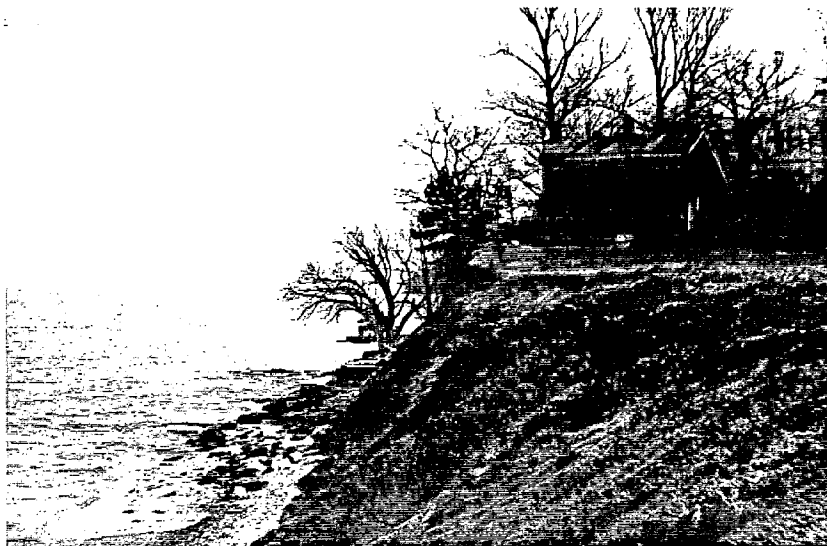
Above: Godfrey Run, Fairplain Road, Girard Township;
 showing cottage in danger on crest of bluff

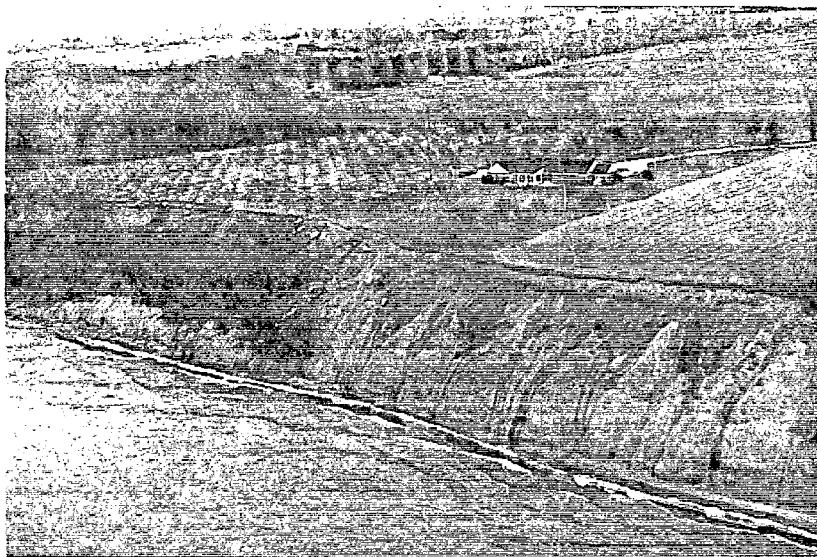
Above: Farm in Girard Township; showing toe erosion due to wave action and bluff crest recession due to ground water runoff

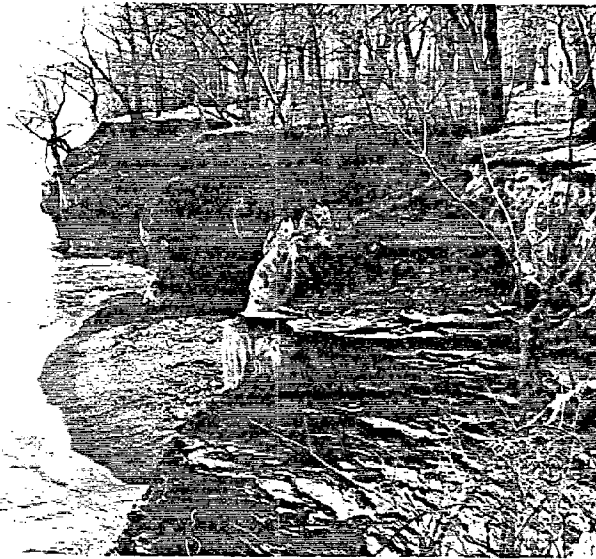
Above: Lawrence Park Golf Club, Lawrence Park Township;
showing differential recession rates causing
scalloped shoreline

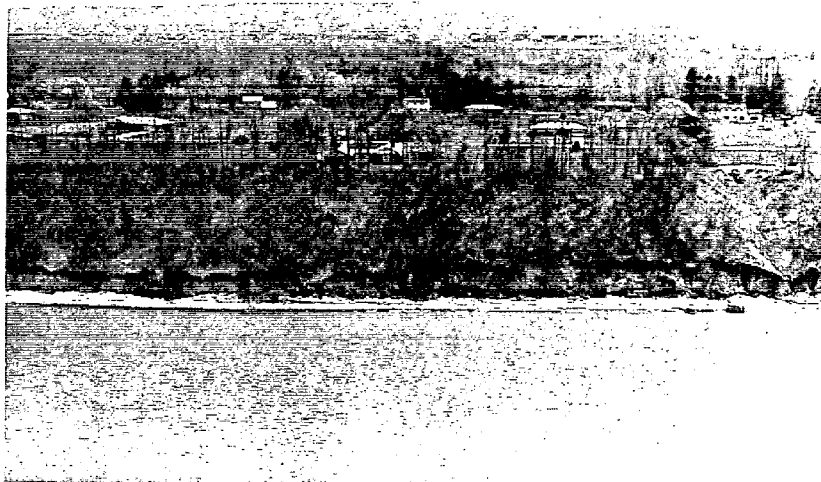
Above: Lake Shore Terrace, Harborcreek Township; showing
serious toe erosion and loss of beach access

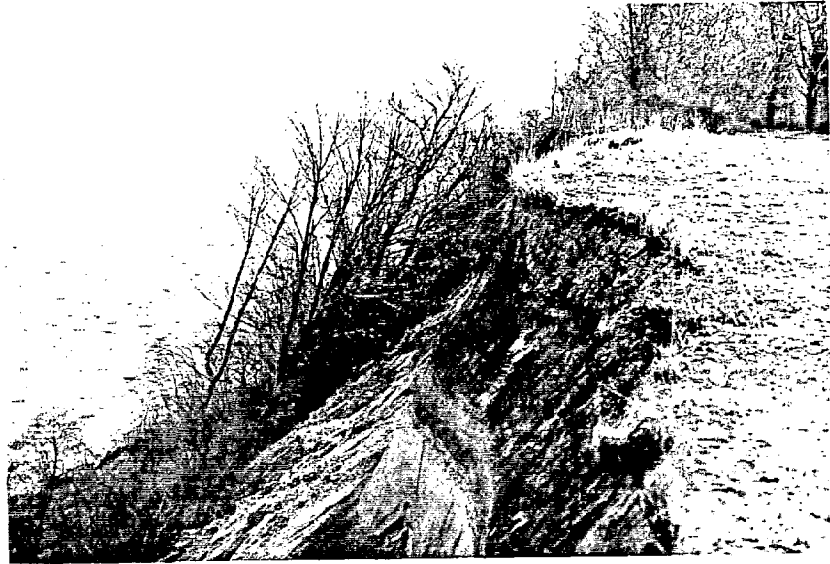
Above and below: Slopes of various slope produced in
relation to recession activity in Springfield
Township

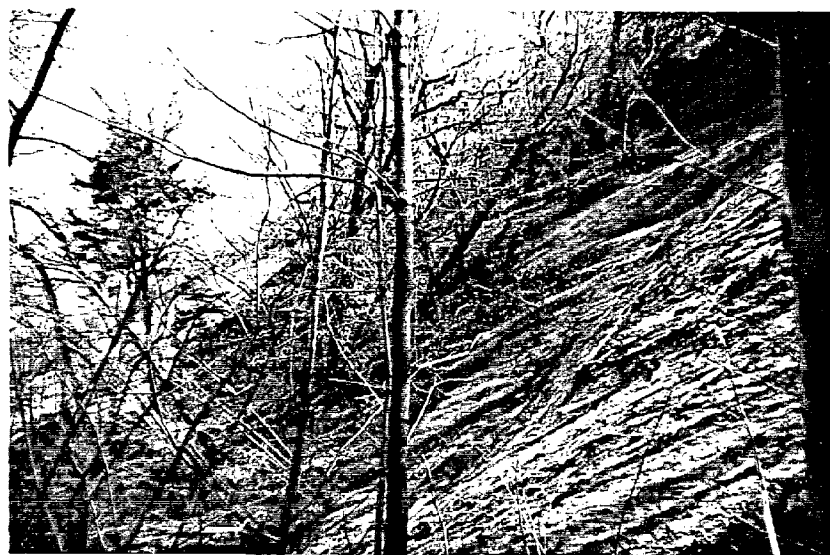
Above: Slumping with associated vegetative disruption, Girard Township

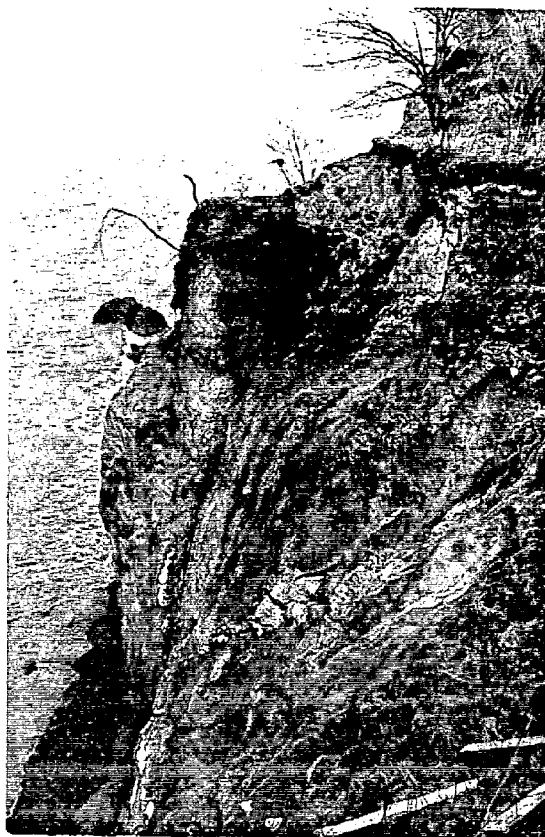
Below: Vertical bluffs with block falls occurring, Springfield Township

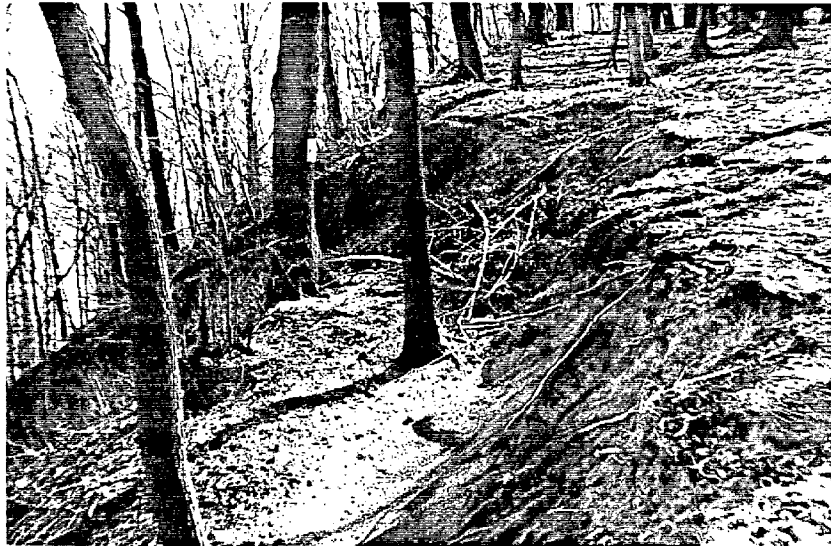
1

Lake Erie Community Park at Point 06-4 has perhaps the most dramatic evidences of bluff recession phenomena on the entire coast. During the past year and a half, Park Commissioners have been recording a massive amount of slope failure producing slump blocks of extraordinary dimension. Slope failure is quite apparent in all stages of occurrence.

Investigators feel that the greatest contributory cause is abnormally high amounts of lacustrine deposits in the area and extremely high ground water conditions over the past three years. The deep sand deposits become quite unstable with the addition of large amounts of water.

- (1) A deranged block with landslide characteristics with complete derangement of materials and vegetation.
- (2) A block approximately 30 ft. by 150 ft. with a vertical displacement of 60 ft. from top of bluff. Trees in second growth are deranged, though some still upright.
- (3) A block with vertical displacement of 8 ft. measuring 41 ft. wide by 165 ft. long, with definite continued movement evident.
- (4) A crack and displacement of a few inches indicates continuation of activity to the east of (3) above. Anticipated dimensional proportions would indicate a slump of material 30 ft. wide by 250 ft. long.

This set of four photographs documents the degree of activity at Lake Erie Community Park. Three distinct slides are evident in (1), (2), and (4). (3) shows aerial view of area.

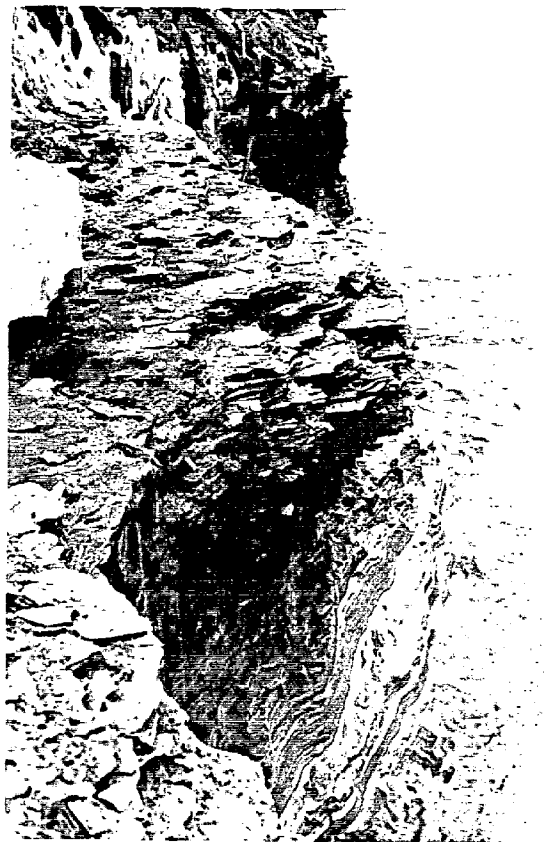
Above and below: Bedrock exposures in Lawrence Park and Harborcreek Township

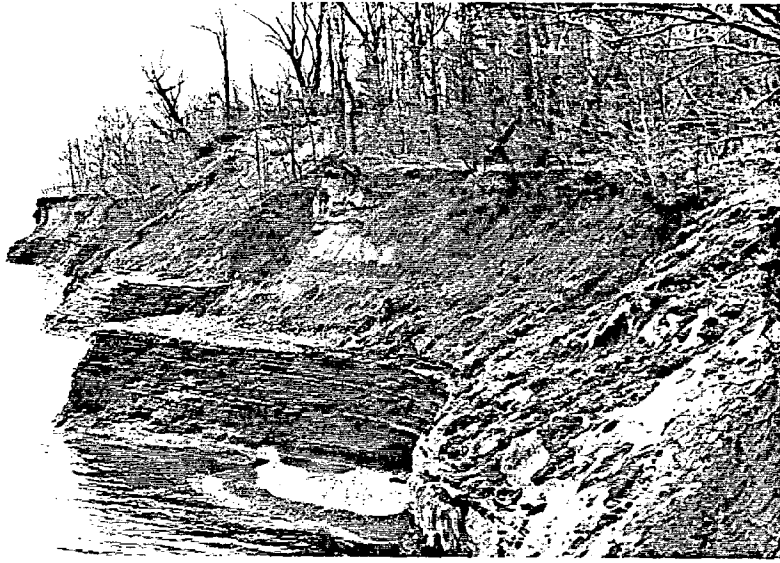
Above and below: Shelving over bedrock produced differential erosion of bluff - Harborcreek Township
